Technical Report GL-97-8
June 1997

In Situ Geophysical Investigation to Evaluate Dynamic Soil Properties at Success Dam, California

by *José L. Llopis, Landris T. Lee, WES*
Russell A. Green, Defense Nuclear Facilities Safety Board

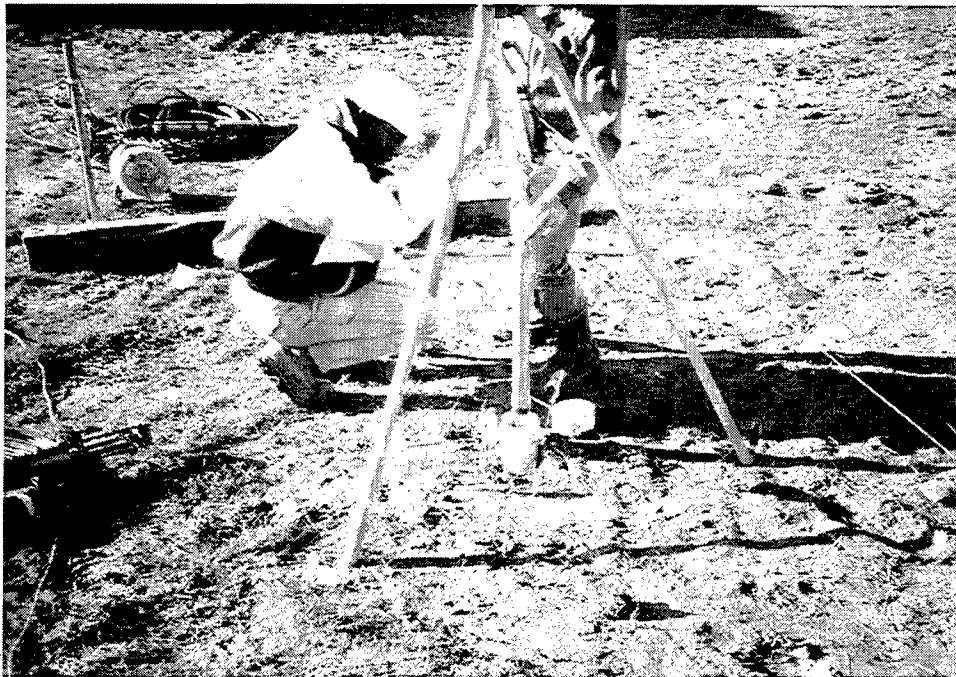
Figure 5. Borehole deviation tool

a. Deviation probe being lowered into boring

b. Surface control unit and winch
